## **Show Dome Façade Study**

**Milwaukee County - Mitchell Park Domes**

## **LOWER LEVEL FAÇADE REVIEW**

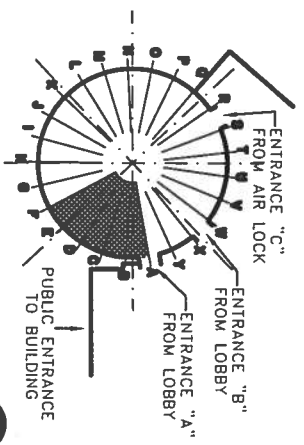
Based on visual observations, the Show Dome review concluded that the facade has broken and leaking glass, faulty aluminum framing components, and a poorly functioning condensate drainage system. All of these issues have created extensive water dripping within the Show Dome. The concrete frame was found to be in fair condition, however, the paint is fading and peeling, and isolated areas of concrete cracking and deterioration are present. At one observed location, the connection between the aluminum façade frame and the concrete frame has completely failed, and this condition needs to be repaired immediately to ensure that the structural integrity of the dome system is not compromised. Delayed maintenance of any of these systems will result in accelerated deterioration and continued failure of the dome components.

- Option 1 includes replacing damaged glass, repairing aluminum framing components, repairing the concrete frame, and recoating the concrete frame.
  - preliminary estimated cost = \$4,000,000 to \$6,000,000.

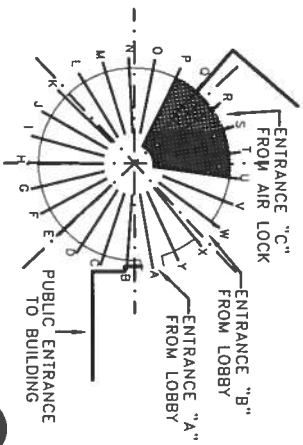
CONCRETE FRAME EVALUATION -  
SHOW DOME SEGMENTS P-U  
NOT TO SCALE

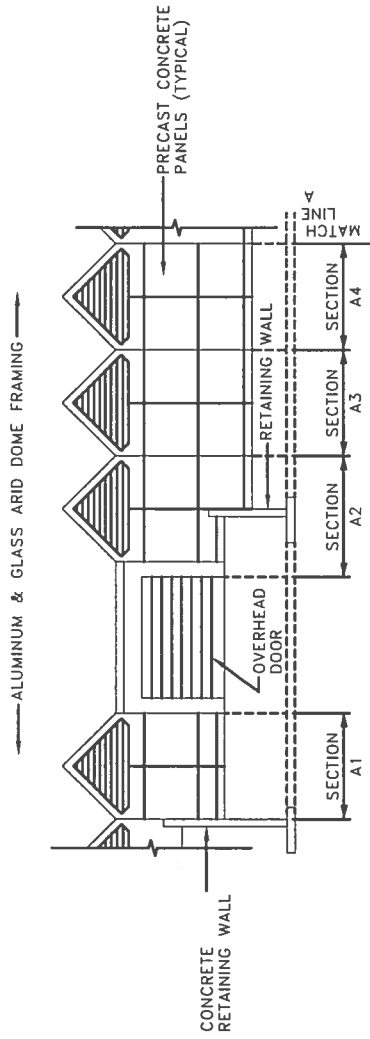
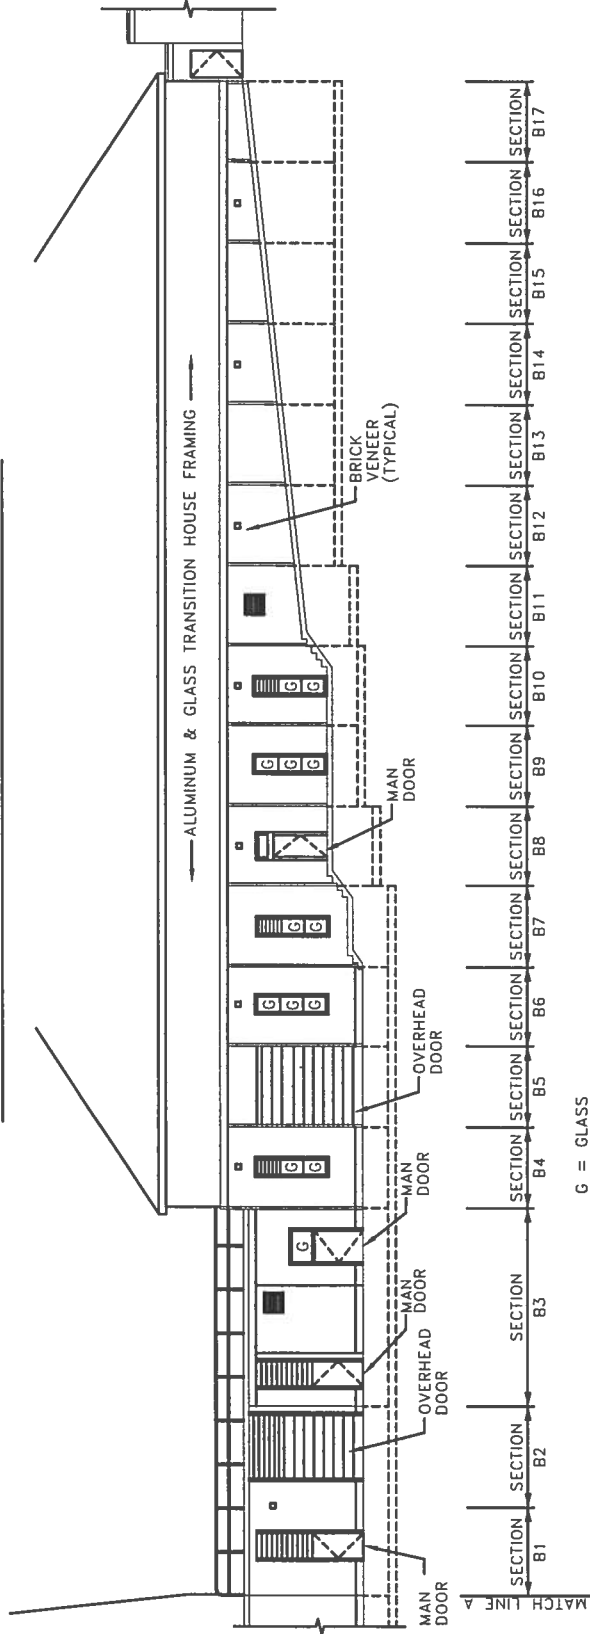
PARTIAL NORTH ELEVATION — ARID DOME

Based on visual observations, and some minor destructive testing, the lower level façade review concluded that the supports for the precast concrete panel and masonry brick cladding are failing, primarily due to rusting of the support and connection steel. Pieces of the façade have broken away from the building. Lack of repairs will result in continued corrosion, and pieces of the façade will continue to break away from the building, potentially causing a significant hazard to Staff and visitors.

Several options for the stabilization or renovation of the brick façade elements at the Mechanical and Transition Greenhouse walls are recommended as follows:

Long term repair and improvements to the system would require complete removal of the brick façade and precast concrete trim pieces. The base angles should be replaced with galvanized steel angles with stainless steel anchors. These angles would have a longer life than the current bare steel angles. To further increase the life of the base support, the angles could be replaced with a concrete curb.

The new brick façade should be installed with a cavity space between the brick and the concrete wall. Base flashing and weep holes should be provided. New galvanized brick ties should be installed at the appropriate spacing. Expansion joints should be added on each side of the corner trim. The corner trim pieces could be replaced with new units to match the existing to maintain the historic look of the façade. The new units should be fastened to the concrete foundation wall. Alternatively, the brick could be cut to fill this corner space.

The window trim should be replaced with new precast concrete units that are attached to the concrete foundation wall. Alternatively, these could be eliminated and replaced with bent metal flashing or with brick returns. The exterior flashing at the top of the wall should be reset and resealed. The interior dome window base should be sealed.
